# **INDOOR AIR QUALITY ASSESSMENT**

**South Egremont School  
42 Main Street  
South Egremont, MA**

Prepared by:  
Massachusetts Department of Public Health  
Bureau of Environmental Health  
Indoor Air Quality Program  
September 2018

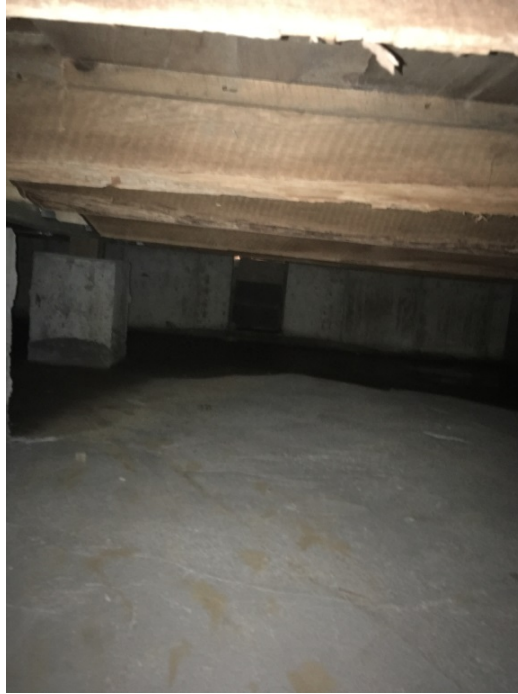
**Picture 1**

Of note is the condition of the crawlspace. Cement on the western side of the crawlspace appears to be wet (Picture 1), which can be attributed to water penetration through the foundation. On the west wall of the building is a newly constructed staircase, which appears to have seams that may allow water to penetrate through the foundation. In addition, downspouts from the roof appear to empty into cement splash blocks (Picture 2). In Picture 2, the splash block appears to be tilted *towards* instead of *away* from the foundation, which would allow for water to gather along the foundation.

**Moisture in the west side of the crawlspace**

2. Replace water-damaged wall-to-wall carpeting.
3. Repair holes/seams in the building envelope, such as in the side steps, to prevent water accumulation in the crawlspace.

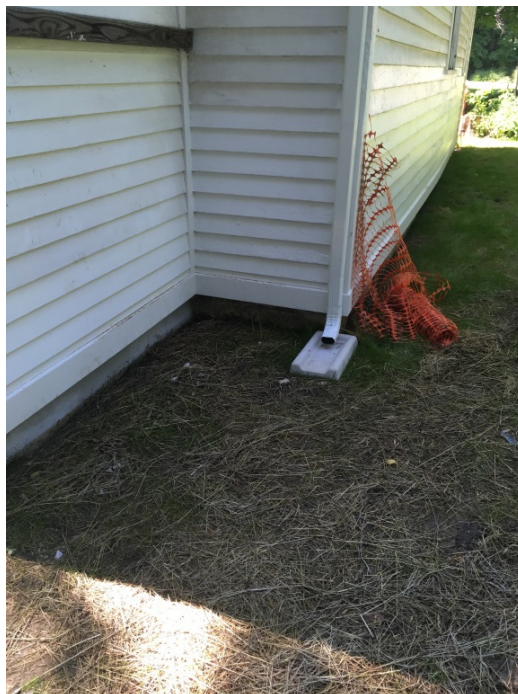
**Picture 2**

**Downspout emptying at base of foundation onto splash block**

It is recommended that downspouts direct water at least five feet away from the base of the foundation. The ground area at the foundation should be covered with a water impermeable material (e.g., clay) that is sloped away from the foundation at a rate of 1 foot height by 5 feet in length so that rainwater shed off walls will drain away from the foundation.

4. Consider extending downspouts at least five feet from the foundation.
5. During occupied periods use openable windows for fresh air. Ensure they are tightly closed when the building is not occupied to prevent moisture and pest infiltration. Ensure openable windows have intact screens to prevent pest entry.
